The purpose of this report is to document the procedures and findings of a comprehensive corridor study for Queens Folly Road.

# QUEENS FOLLY ROAD CORRIDOR STUDY October 2024

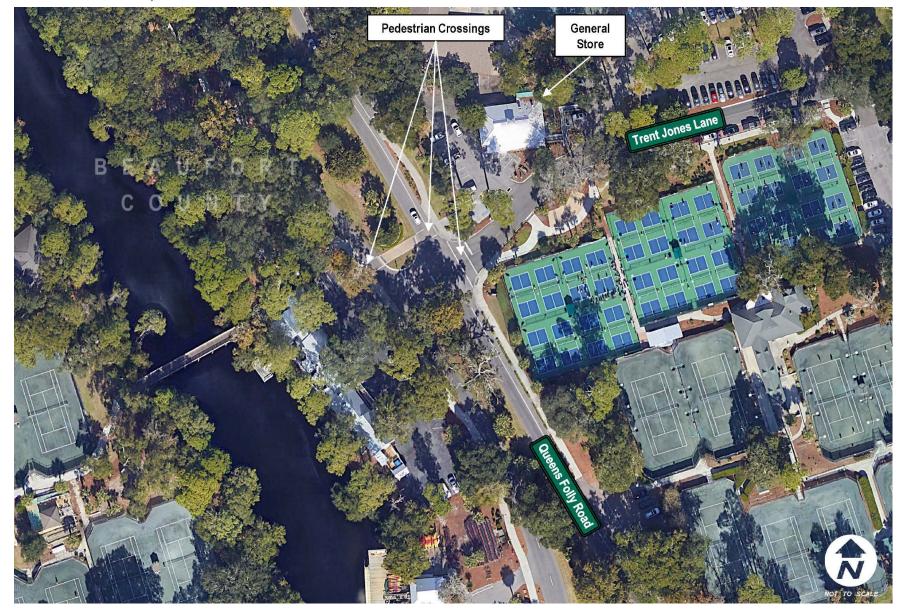
Exhibit 2.1 – Queens Folly Road & Trent Jones Lane Intersection

The Queens Folly Road & Trent Jones Lane intersection shown in **Exhibit 2.1** had significant pedestrian and bicycle activity throughout the observation time frame, particularly between 9:30 AM and 12:00 PM. The existing pedestrian crosswalks as shown in **Exhibit 2.2** do not have the ladder style markings which could be utilized to increase visibility. This intersection also lacks pedestrian crossing signage for vehicles at or near the provided pedestrian crossings to alert vehicles that pedestrians may be crossing.

Based on the field observations and the traffic counts, it is recommended that Trent Jones Lane be converted to a rightin/right-out access. With this change to the intersection, vehicles that were previously making left turns would be directed to make U-turns at the next adjacent intersection. These changes to the intersection are likely to improve the safety of the intersection by preventing the queue that forms in the median, therefore preventing the blocking of the southbound approach. **Exhibit 3.6** shows the reassigned traffic volumes after converting this intersection into a right-in/right-out access.

It is also recommended to realign the pedestrian crosswalk to improve visibility and remove a potential conflict between pedestrians/bicycles and vehicles. **Exhibit 3.7** shows the recommended changes to the intersection and crosswalk. The new configuration will remove the conflict between pedestrians crossing the northbound approach of Queens Folly Road and vehicles turning right from Trent Jones Lane. This is likely to improve safety and allow right-turning vehicles to turn during the gaps in traffic without having to accommodate pedestrian/bicycle crossings. With these recommended changes the occasional heavy vehicle (WB-62) would have to encroach into the westbound egress lane along Trent Jones Lane while making a northbound right turn. However, this is not uncommon in residential areas. **Appendix D** shows the recommended changes to the intersection with heavy vehicle turning path marked.

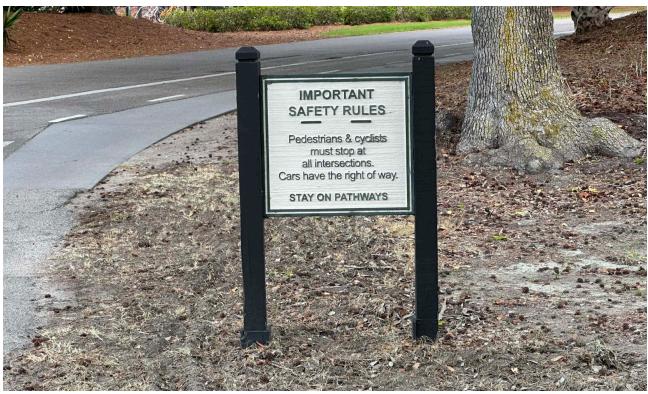
Exhibit 2.3 – Observation Photo #2 – Existing Signage

The provided signage along the corridor shown in **Exhibit 2.3** directs the pedestrians to yield to vehicles. South Carolina Code of Laws Section 56-5-3150 – Pedestrians' right-of-way in crosswalks states that "When traffic-control signals are not in place or not in operation the driver of a vehicle shall yield the right-of-way, slowing down or stopping if need be to yield to a pedestrian crossing the roadway within a crosswalk when the pedestrian is upon the half of the roadway upon which the vehicle is traveling or when the pedestrian is approaching so closely from the opposite half of the roadway as to be in danger." Section 56-5-3150 – Crossing at other than crosswalks states that "Every pedestrian crossing a roadway at any point other than within a marked crosswalk or within an unmarked crosswalk at an intersection shall yield the right-of-way to all vehicles upon the roadway."

Install pedestrian crossing signs (W11-15) and arrows (W16-7p) per the *Manual on Uniform Traffic Control Devices* (MUTCD) at all pedestrian crosswalks to alert drivers of nearby pedestrians;

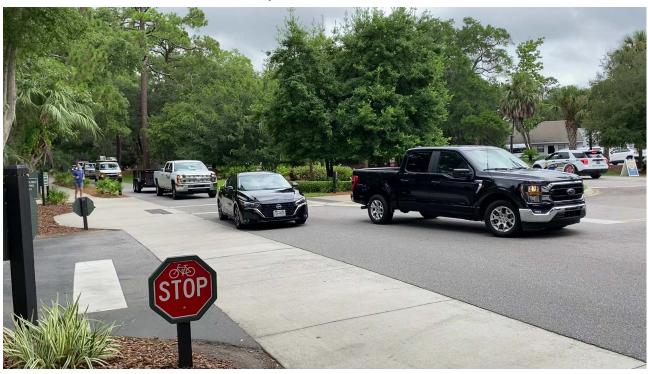
Exhibit 2.8 – Observation Photo #7 - Queens Folly Road & Trent Jones Lane Intersection

Throughout the observation period there were very minimal gaps in traffic along Queens Folly Road which caused various issues, one being left-turning vehicles (southbound left and westbound left) becoming "stuck" in the median break and blocking through traffic when more than one vehicle intended to make a left turn (shown in **Exhibit 2.4** and **Exhibit 2.5**). When the southbound approach was blocked by two or more vehicles desiring to make a left turn, the through traffic would develop a queue (shown in **Exhibit 2.6**). Once the southbound queue had developed, southbound through vehicles would drive around those turning vehicles and drive over the multiuse path to avoid the backup (shown in **Exhibit 2.7**, **Exhibit 2.8**, **Exhibit 2.9**, & **Exhibit 2.10**).

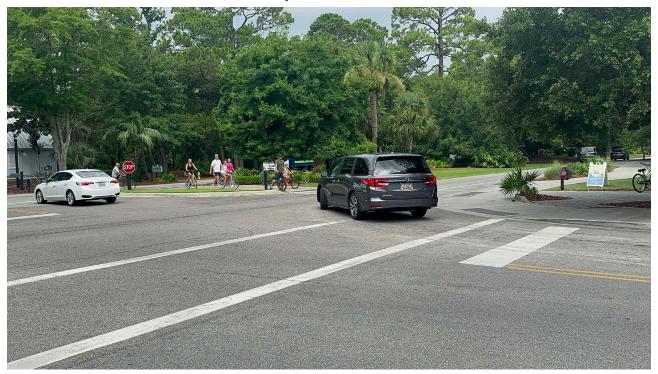
Exhibit 2.11 – Observation Photo #10 - Queens Folly Road & Trent Jones Lane Intersection

The minimal gaps in traffic along Queens Folly Road also created long waiting durations for the pedestrians and bicyclists since the signage states that they must yield to vehicles. Often times when gaps in traffic presented themselves, there were conflicting movements between southbound U-turns and left turns, northbound right turns, westbound right turns, and the pedestrians that desired to cross the various crosswalks (shown in **Exhibit 2.11**).

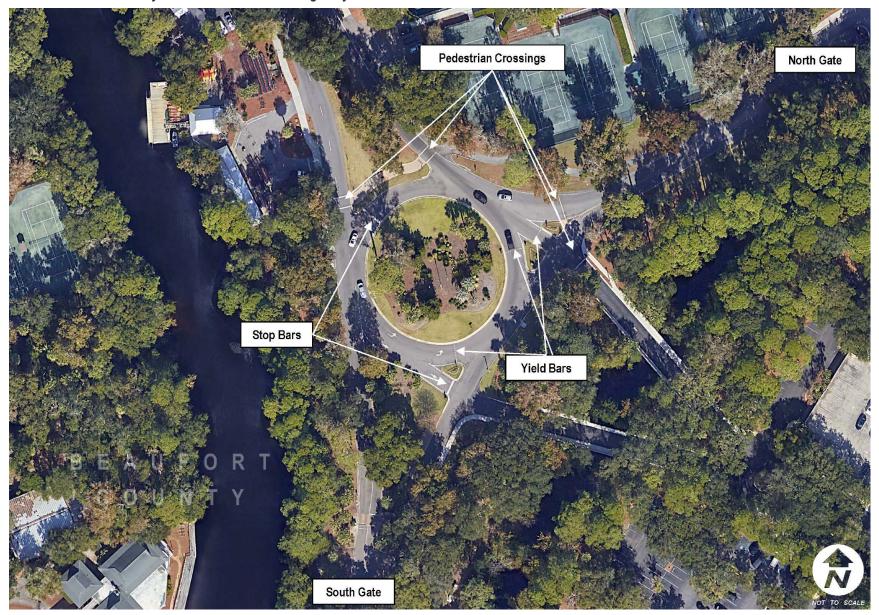
The Queens Folly Road traffic circle (shown in **Exhibit 2.12**) had significant pedestrian and bicycle activity throughout the observation period. The pedestrian crossings in the traffic circle did not have the ladder style markings (see **Exhibit 2.13**) which could be used to enhance the visibility. The traffic volumes in the traffic circle were observed to be relatively consistent, and therefore there were not frequent gaps in traffic that allowed for pedestrians and bicycles to cross. The infrequent vehicular gaps created long durations of wait time for the pedestrians and bicycles. The pedestrians were directed to yield to vehicles, but there was confusion with vehicles that stopped to allowed pedestrians across the street, while others did not (shown in **Exhibit 2.14** and **Exhibit 2.15**).

The overall operation of the Queens Folly Road/Hotel Circle & Mooring Buoy/Ocean Lane (Traffic Circle) instructs that vehicles entering the traffic circle have the right-of-way while the vehicles inside the traffic circle must yield to those entering. This traffic circle operates differently from a traditional roundabout and based on the field observations it appeared to cause confusion with the yielding process for both vehicles and pedestrians. It is recommended that the traffic circle be converted to a more traditional roundabout by giving the vehicles inside the traffic circle the right of way and directing the entering vehicles to yield. **Exhibit 3.8** illustrates the recommended changes to the traffic circle.

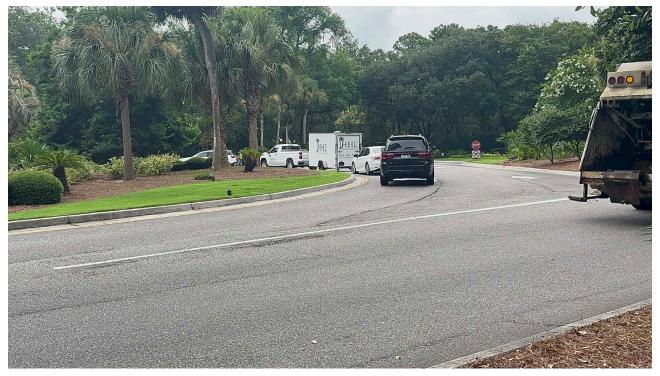
Exhibit 2.16 – Observation Photo #14 - Queens Folly Circle

The traffic circle has different operations than a modern roundabout. At this location, the circulating traffic must yield to entering traffic, which is the opposite of current modern roundabouts. There were numerous times where vehicles were observed yielding as they entered the traffic circle, causing confusion to circulating vehicles. Overall, the traffic circle appeared to cause confusion for drivers and pedestrians, which caused the queue in the circle to grow to multiple vehicles (shown in **Exhibit 2.16**).

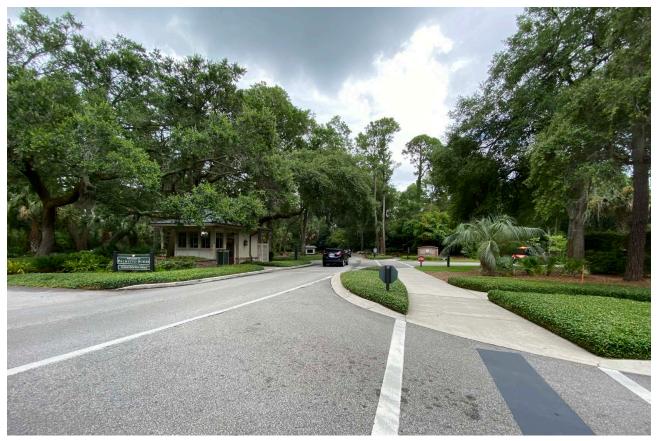
Exhibit 2.17 – Observation Photo #15 – Front Gate

The Queens Folly Entrance Gate shown in **Exhibit 2.17** is not operated during daytime hours, and therefore delays are limited.

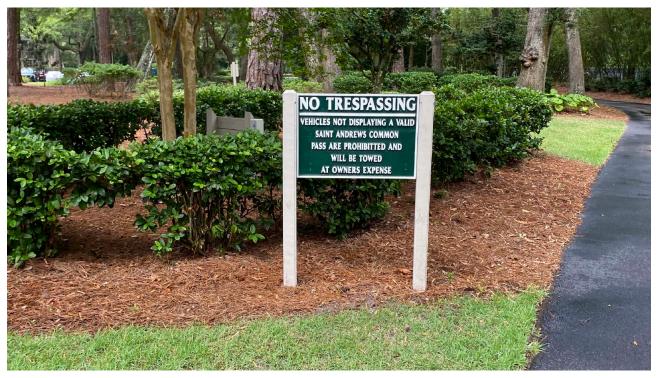
Exhibit 2.18 - Observation Photo #16 - St Andrews

The St. Andrews Commons entrance and signage is shown in **Exhibit 2.18** which provides warning for improper entry. Based on the collected count data and field observations, traffic volumes in and out of this entrance were limited - less than 30 vehicles entering or exiting in the peak hour(s).

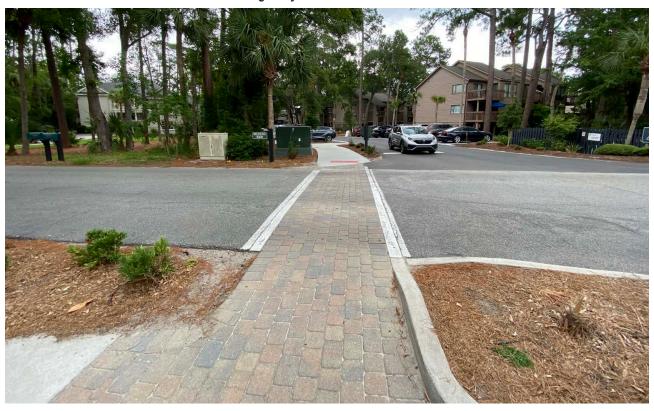
Exhibit 2.19 – Observation Photo #17 – Mooring Buoy & Dunes House Lane

The intersection of Mooring Buoy & Dunes House Lane is shown in **Exhibit 2.19** and **Exhibit 2.20**. Based on the collected count data, this intersection experiences a high volume of pedestrian traffic crossing the pedestrian crosswalk which does not have pedestrian crossing signs present.

Install rectangular rapid flashing beacons (RRFBs) at the crosswalk at the intersection of Mooring Buoy & Dunes House Lane. RRFBs are pedestrian-actuated enhancements used in combination with a pedestrian crossing warning sign to improve safety at uncontrolled, marked crosswalks. The device includes two rectangular-shaped yellow indications, each with an LED-array-based light source, that flash with high frequency when activated.

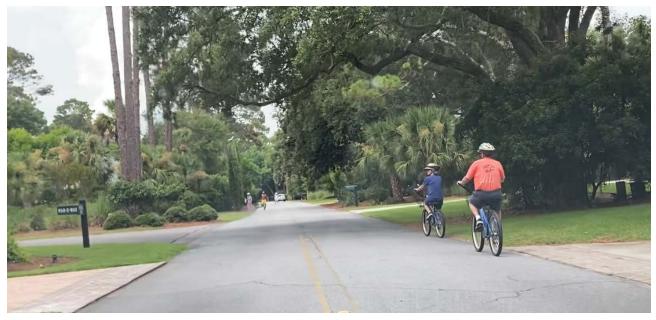
#### Exhibit 2.21 – Observation Photo #19 – Mooring Buoy & Man-O-War

Mooring Buoy east of Port Tack was also observed. This observation indicated notable bicycle and pedestrian activity along Mooring Buoy in the vehicular travel way, as illustrated in **Exhibit 2.21** and **Exhibit 2.22**. These observations are corroborated by data collection along Mooring Buoy east of Port Tack which indicated that, along Mooring Buoy an average of just over 25 pedestrians per hour were counted during the AM peak period (7:00 – 10:00 AM) and just under 10 pedestrians per hour during the PM peak period (3:00 – 6:00 PM). Additionally, there is a horizontal curve along Mooring Buoy which contributes to potential sight distance issues between vehicles and pedestrians and bicycles, which is exacerbated by unfamiliar drivers who may not be aware of the high pedestrian and bicycle activity within the vehicular travel way in this location.

Install a multiuse path along the north/west side of Mooring Buoy beyond Port Tack to the end of Mooring Buoy (continuing the existing multiuse path which currently terminates at Port Tack).

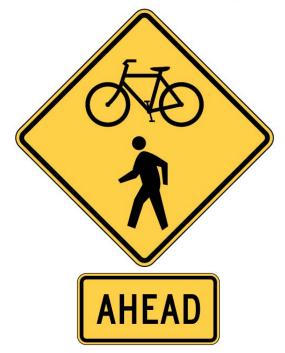
#### Exhibit 3.3 – Bike and Pedestrian Crossing Sign with Ahead Supplemental Warning Plaque

Source – MUTCD 11th Edition

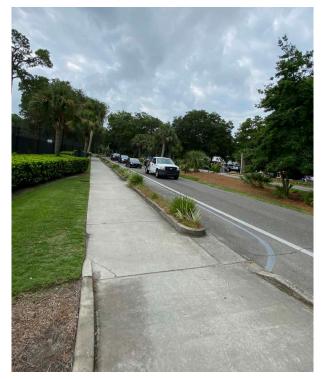
#### Exhibit 3.5 - Existing Planted Buffer

Complete/install a planted buffer along the entire frontage of Queens Folly Road in both directions in between Trent Jones Lane and the traffic circle an additional safety measure for pedestrians and bicyclists (adding to the existing buffer, shown in Exhibit 3.6); and
